NATIONAL DAM SAFETY PROGRAM. ISCHUA CREEK WATERSHED DAM NUMBER --ETC(U)

**ISCHUA CREEK WATERSHED
DAM No. 1**

**CATTARAUGUS COUNTY, NEW YORK
INVENTORY No. N.Y. 583**

**PHASE I INSPECTION REPORT
NATIONAL DAM SAFETY PROGRAM**

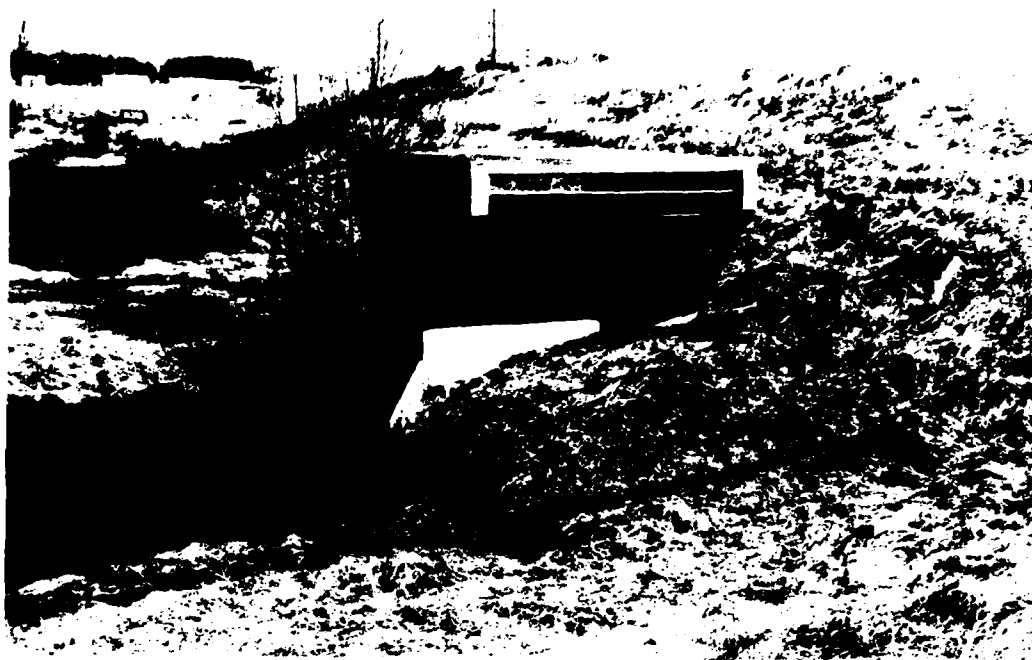
The brush growth is heavy on this embankment impeding inspection of the slopes. Shrubs were noted along the north upstream abutment contact and small trees are growing just to the north of the intake structure on the upstream slope and along the cobble drain at the north downstream toe.

1. Principle spillway inlet structure. Note trees.

- Remove the trees and saplings including the roots from the embankment slopes. Backfill the resulting voids with suitable compacted material.
- Regrade and fill in the erosion gullies on the downstream slope and around the outlet structure. Reseed the disturbed areas.

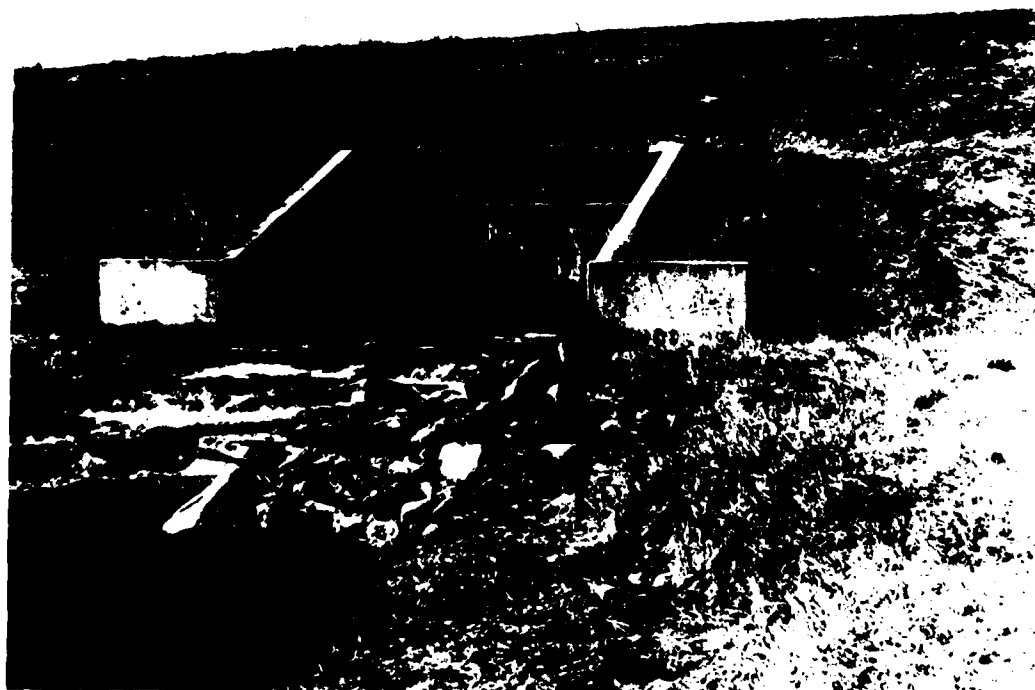
The structure is in good condition. Minor spalling was observed on the concrete baffle. Minor erosion behind both wingwalls were noted. There is a 5' x 14'1" opening between the inlet wall and baffle that presents a potential hazard to people.

4. Principle spillway impact basin.

- Place a grate over the opening in the impact basin between the inlet wall and baffle.
- The debris and vegetation should be cleared from the downstream channel, outlet basin, auxiliary spillway channel and embankment surfaces periodically. A program of periodic mowing and cutting of the embankment and outlet channels should be provided.
